MEASUREMENT OF POLYETHYLENE PIPE PARAMETERS DURING AN
OCEAN DEPLOYMENT

Final Report

By
R. F. Hoppmann
P. L. Ritchie

November 15, 1978

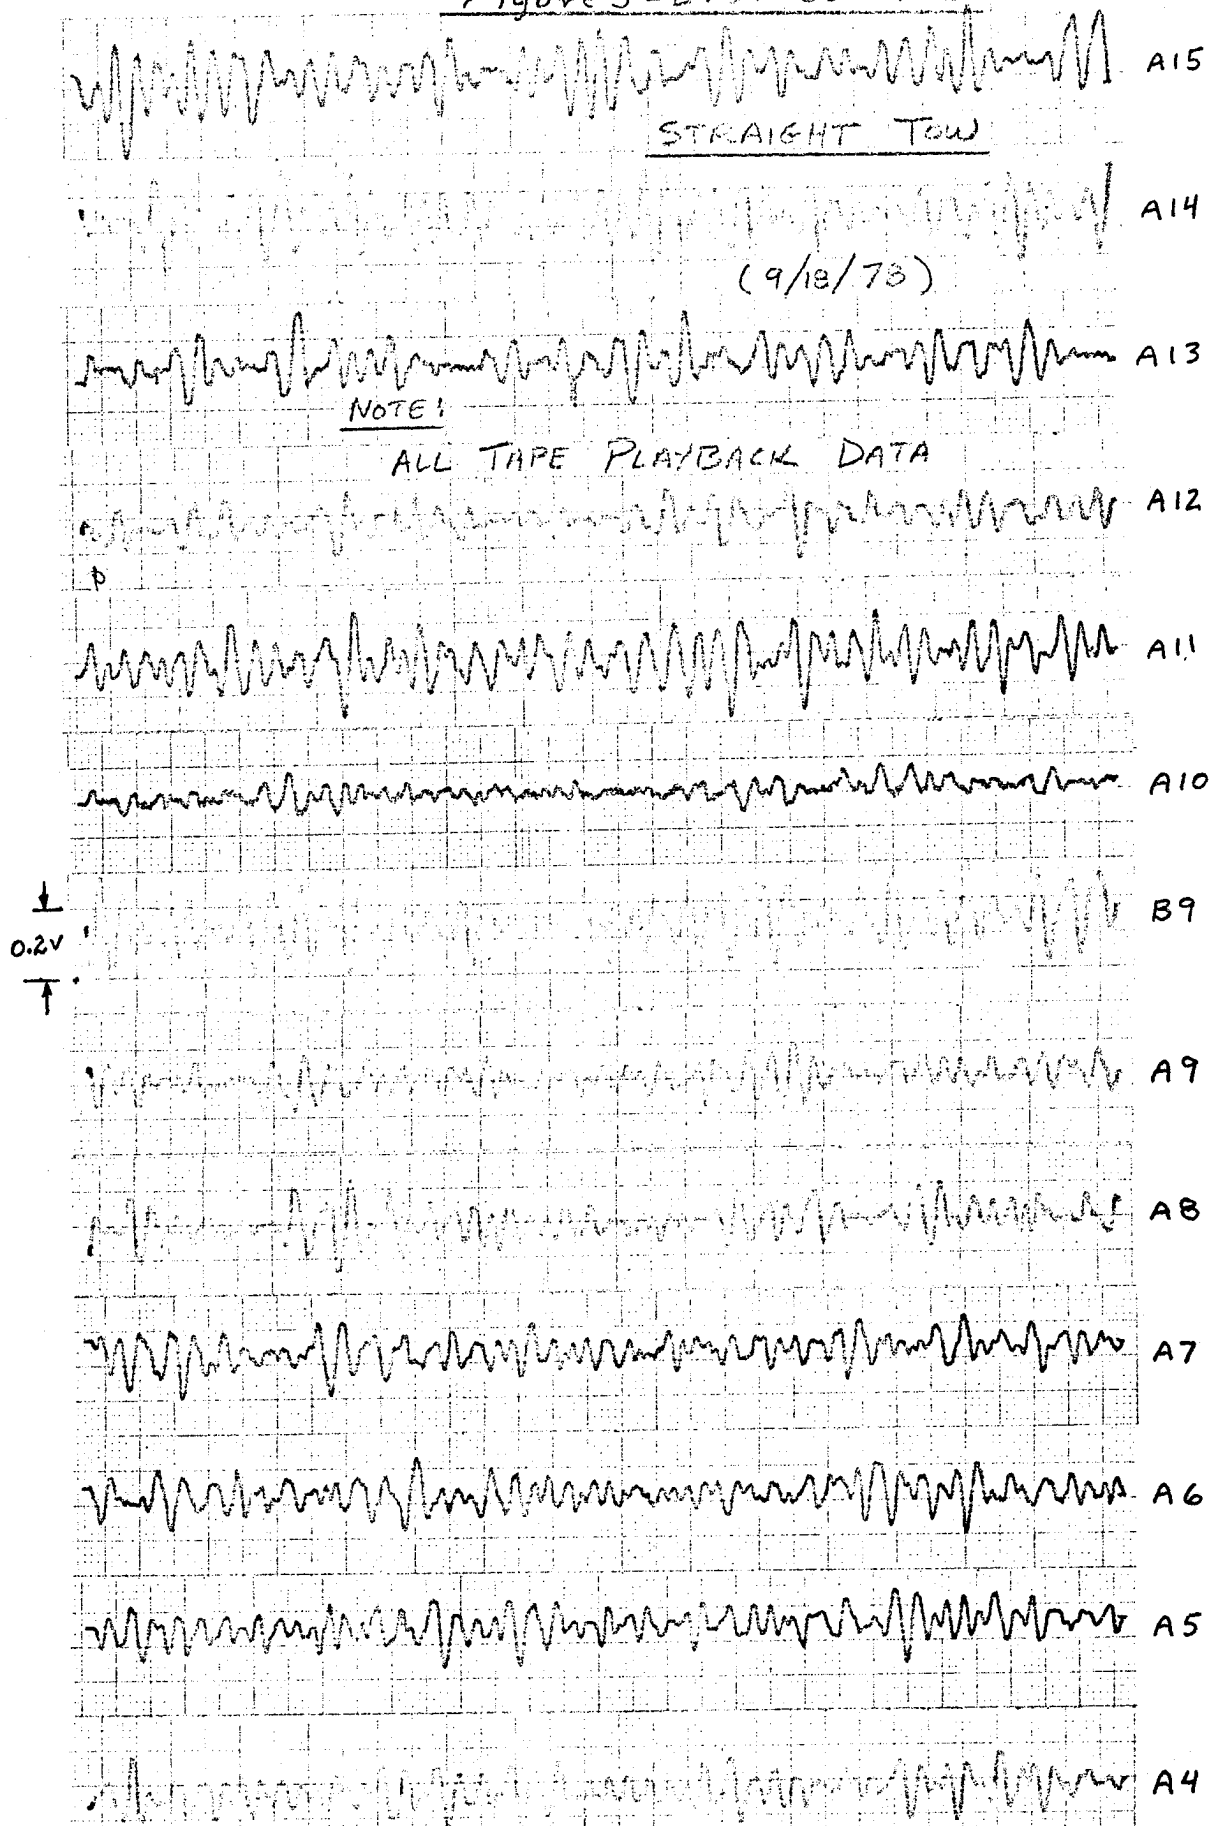
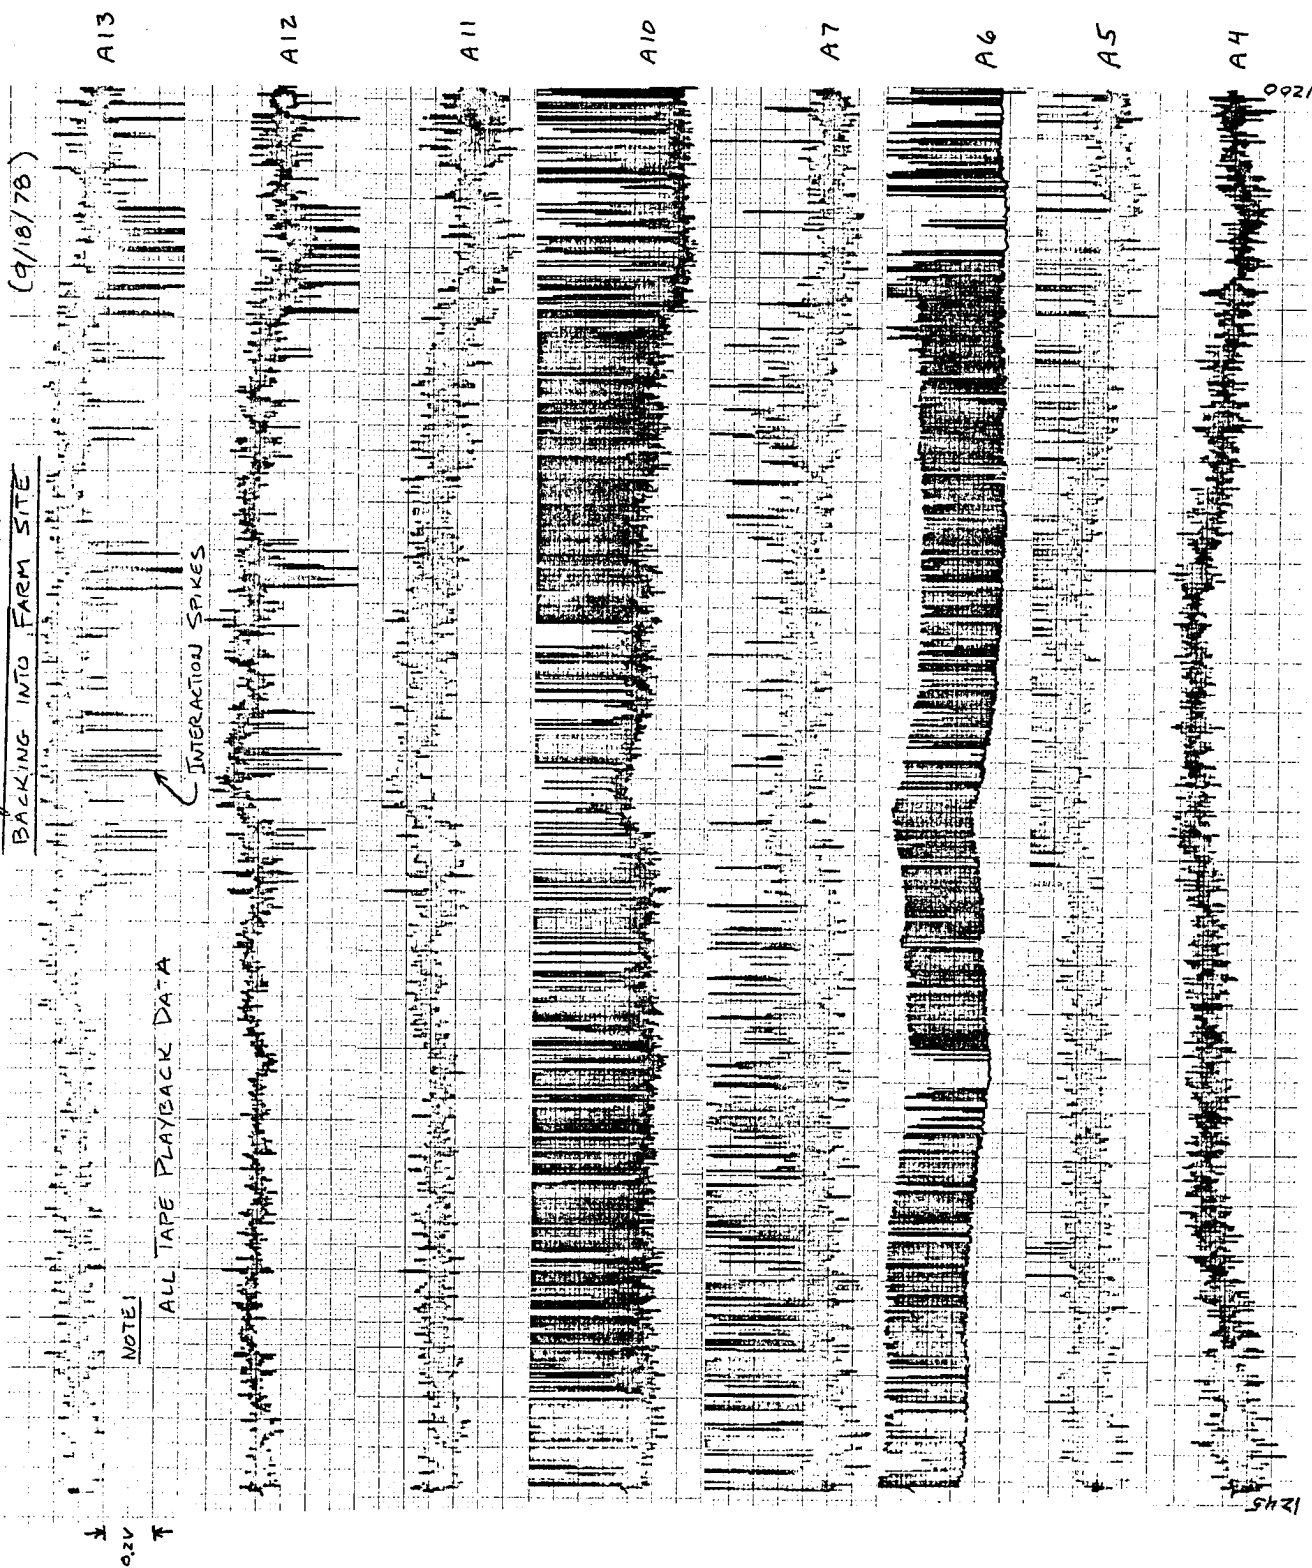
Figure 6a - LVDT OUTPUTS
BACKING INTO FARM SITE

During this interval, some sensor malfunctions in the "A" harness began to appear. Figure 6 illustrates pipe tension, bending and wave motion as the "Trojan" backed into the farm area and moored to the machinery buoy. Noise spikes such as on the A13 and A12 traces are probably interactive power fluctuations caused by an intermittent in power supplying their stable-mate A5. A list of sensor common power groups is presented in Table 4 and should be very useful in identifying possible interactions. We have concluded that recorder problems are effecting A8, A9 and possibly A6 at this time. By the end of tape 1-2, sensor channels A1, A6, A8, and A9 had probably failed. The other sensors were either working or were recorded on tapes we could not review. No failure analysis has been conducted to define the potential causes of apparent sensor failures.

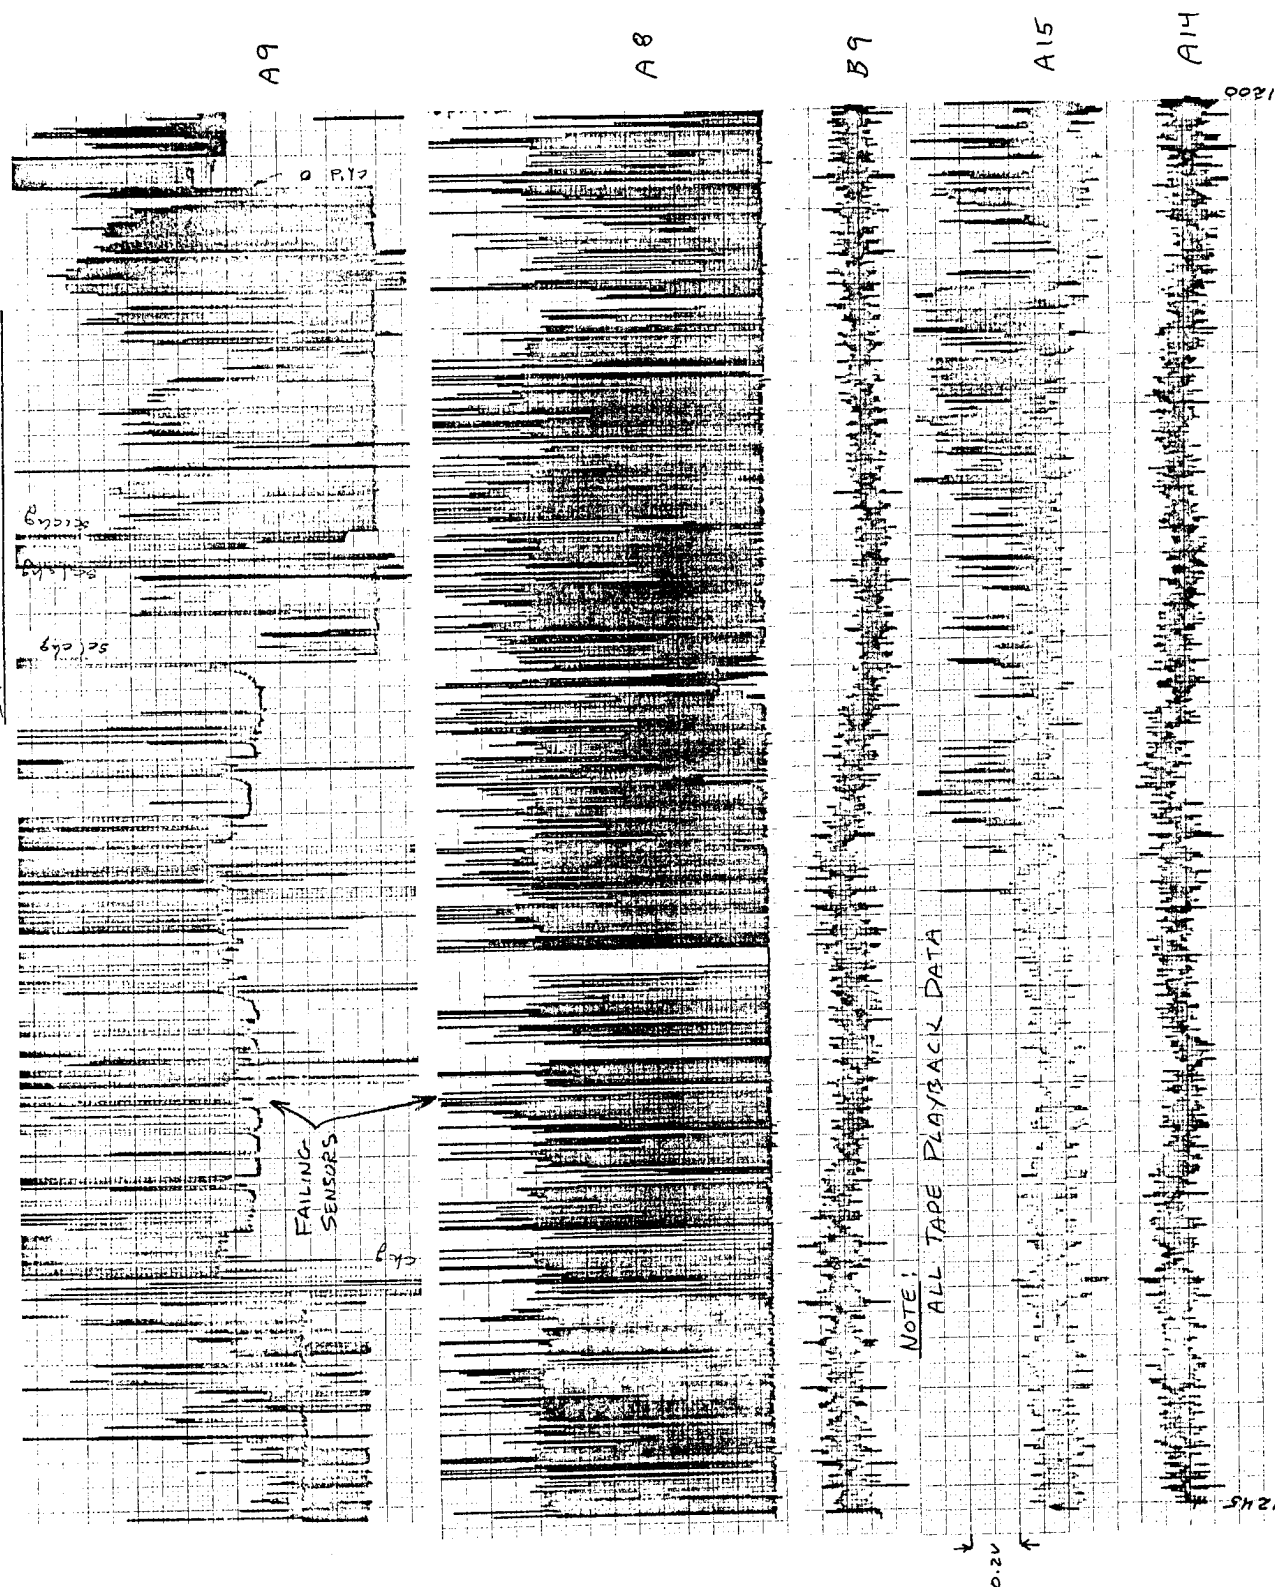
Figure 7- LVDT OUTPUTS

PIPE FLOODING

(NOTE: INCORRECT TIME READINGS - SEE TEXT)

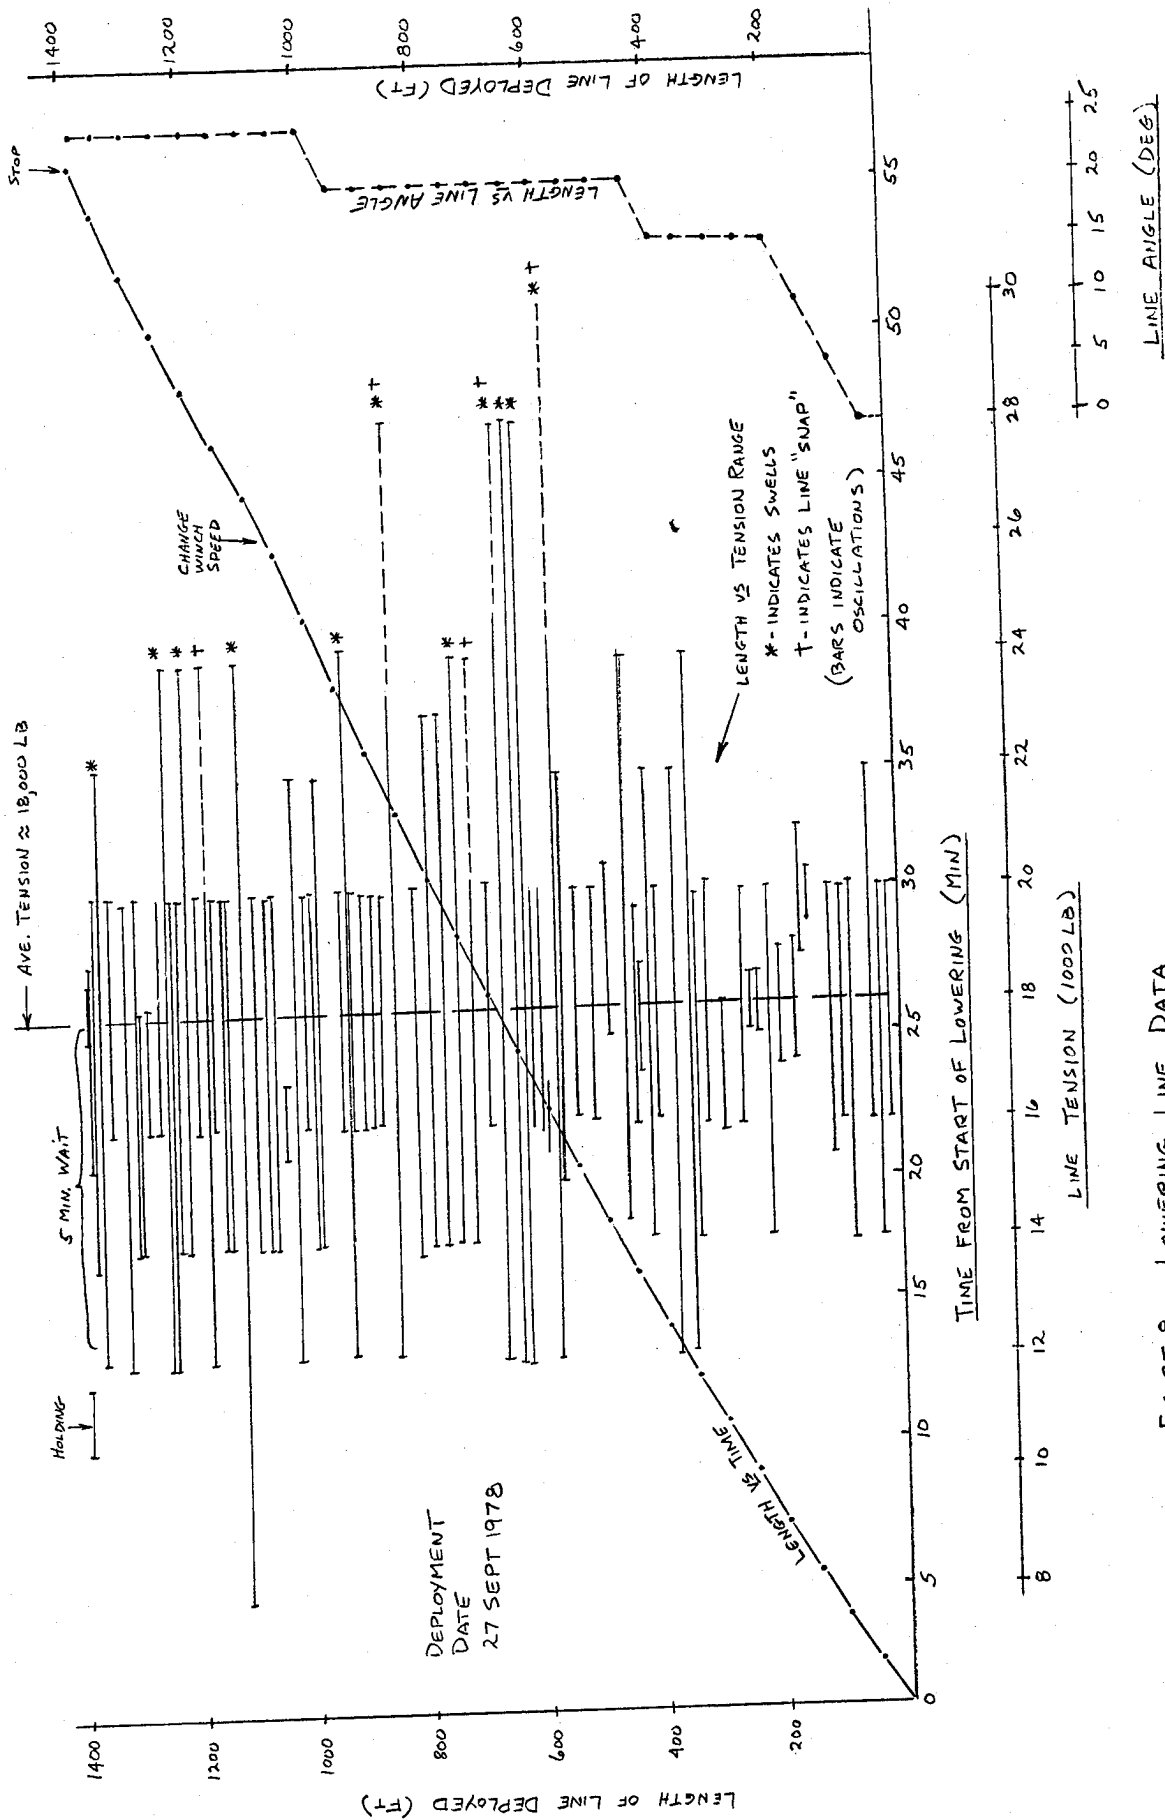
FIGURE 8 LOWERING LINE DATA

are presented in the chart of Figure 8 which shows tension, line angle, and time from start of lowering as functions of length of line deployed. It is seen that the average values of tension held at around 17,000-18,000 lbs. during most of the one-hour lowering operation. Variations were generally on the order of $\pm 2,000$ lbs. with a few larger variations of up to $\pm 10,000$ lbs. observed with passage of unusually large swells or with "jumping" or slipping of individual cable turns on the payout drum. Fluctuation periods of two seconds were "typical". The transient tension excursions observed had no detectable effect on the overall smoothness of the lowering operation. The final "holding" tension at the end of the payout, prior to cutting the lowering line to complete the upending operation, was $11,000 \pm 500$ lbs. Line angles (0° referenced to vertical) during the operation varied from 0° at the initial lowering, to a maximum value of 25° . The line angle rapidly reached $15^\circ - 20^\circ$ shortly after the start of the operation. There appears to be no clear correlation between tension and line angle but it could easily be masked by the transients in the tension data.
